Conditions Assessment & Feasibility Study

Franklin City Hall & Opera House Franklin, NH

March 22,2024

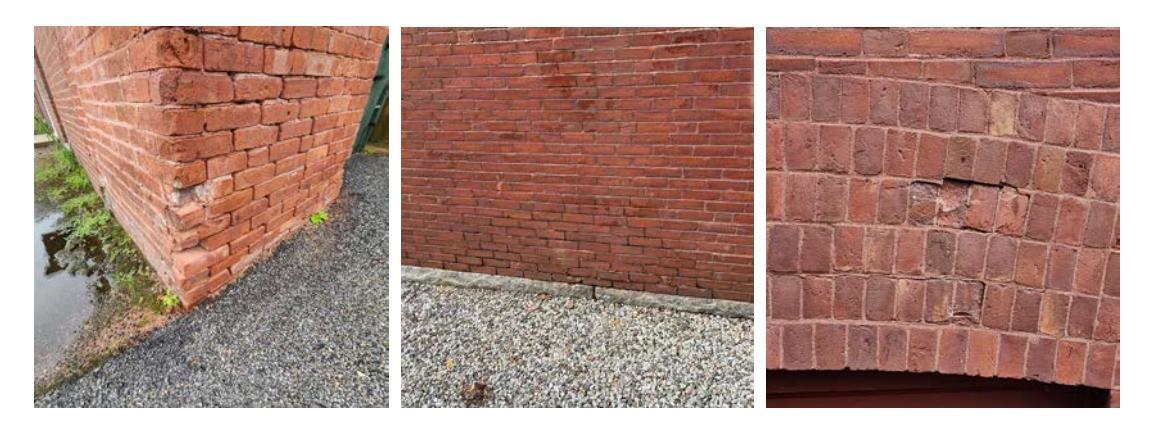
1. Brick is crumbling in multiple areas, there are cracks in some parts of the mortar and will need localized repointing and repair.

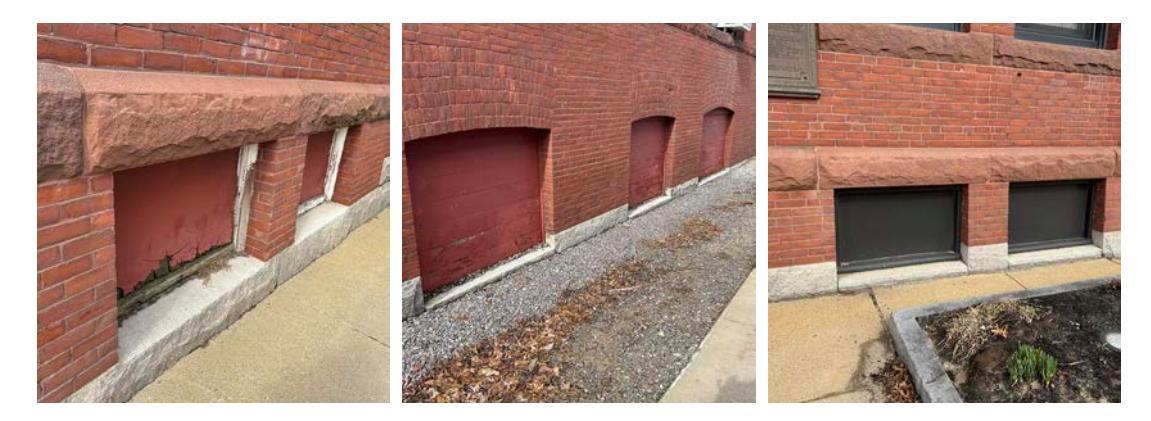
2. Basement windows have been boarded up on the street side, windows should be replaced in the same place to allow for more daylighting in the basement.

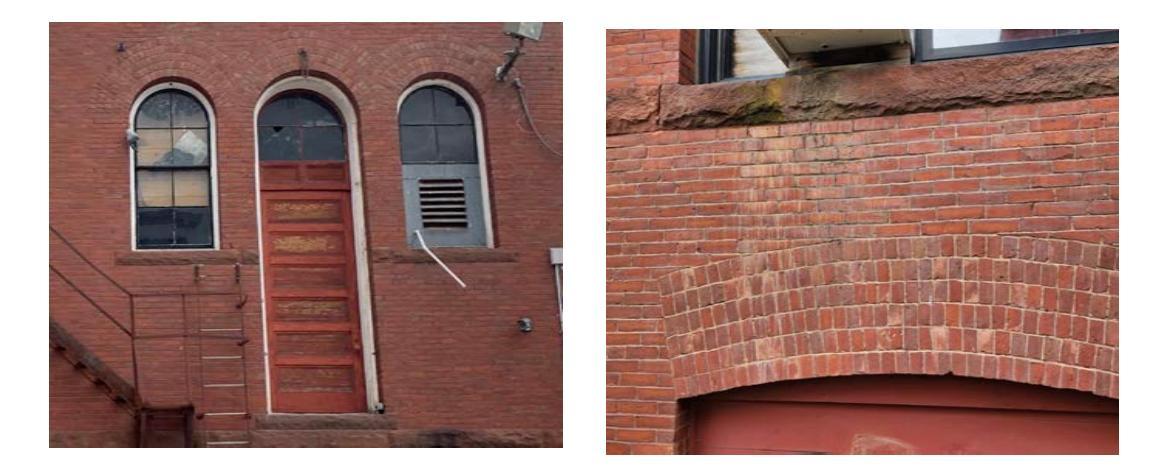
3. There are windows where the glass is cracked or damaged and will need to be repaired. The window sills are mostly in good condition though there a few that will need further investigation, specifically under the window AC units where water damage has occurred.

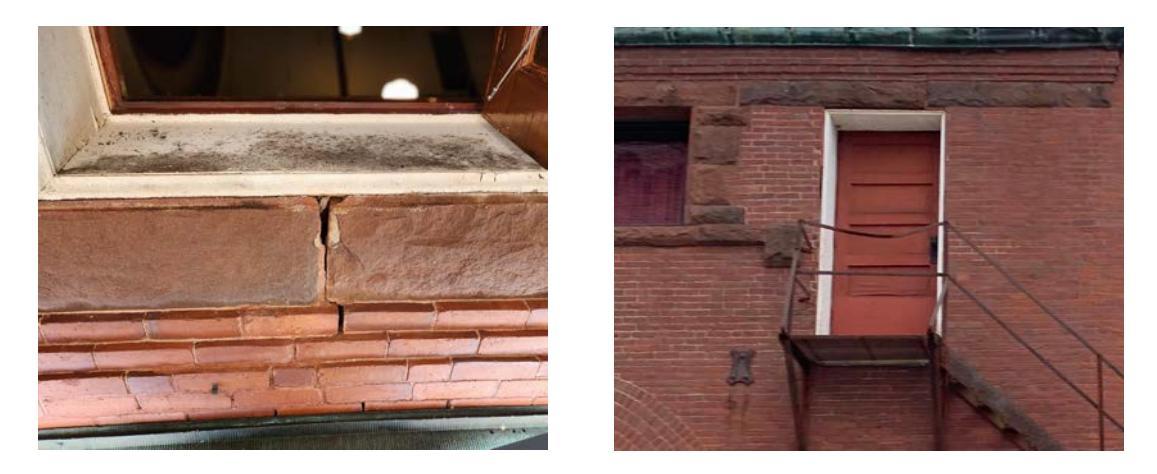
4. The brownstone masonry headers are cracked or deteriorated above the exterior doors in multiple locations, repair or replace as needed, specifically at the mezzanine exit doors on both sides. There is mold and mildew growing on the threshold above the doors that will need to be cleaned. All exterior door flashing should be investigated and reflashed.

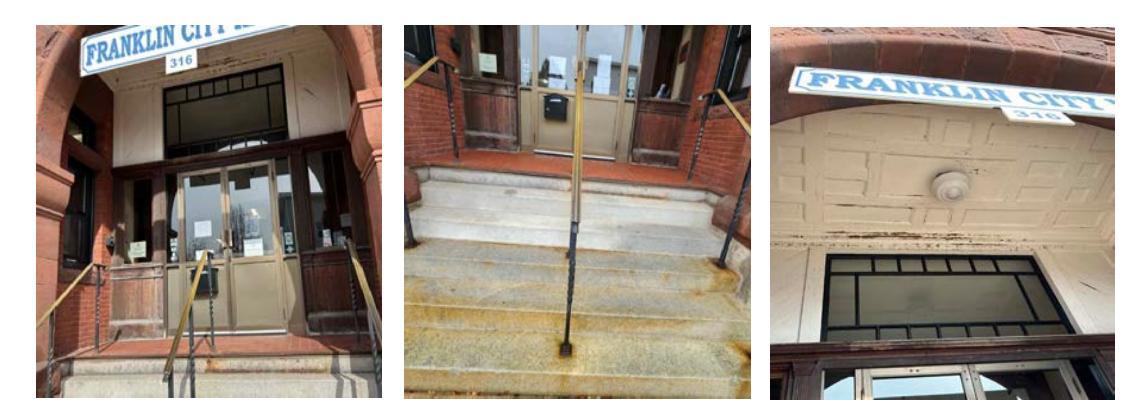
5. Repair moisture damage at front entry and repair or replace the wood where decayed. The front entry railings should be repaired and repainted. The landing currently does not meet ADA standards as the primary means of entry. However, it does meet life safety code. (Note: and ADA compliant entry added to another side of the building could potentially eliminate the need to reconfigure this main entry to comply with ADA standards.)

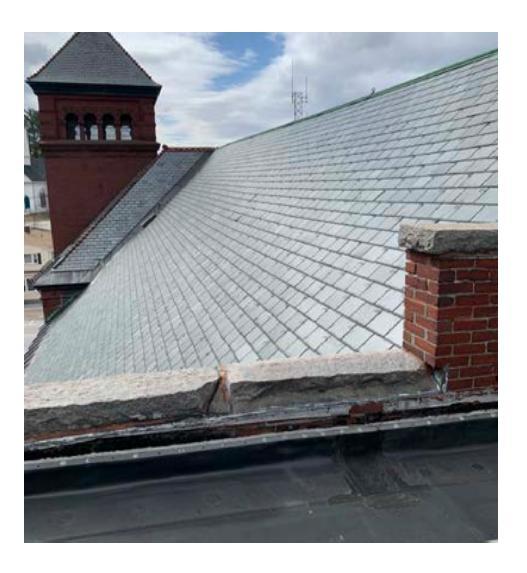
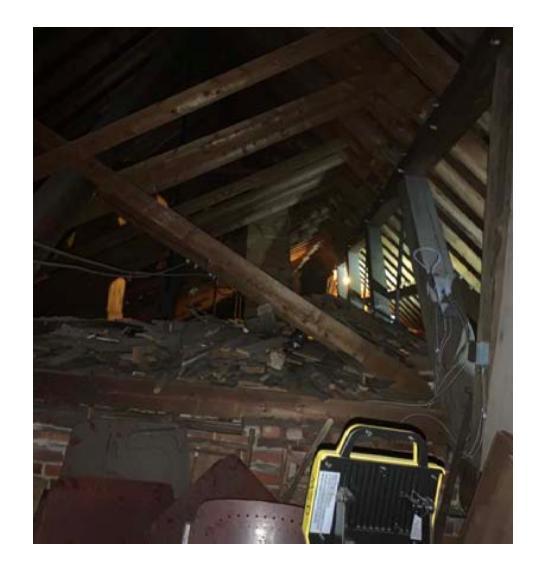
6. Slate roofing and flashing is nearing the end of life expectancy. There is evidence of moisture damage to the opera house ceiling facing the street where the flashing should be investigated thoroughly

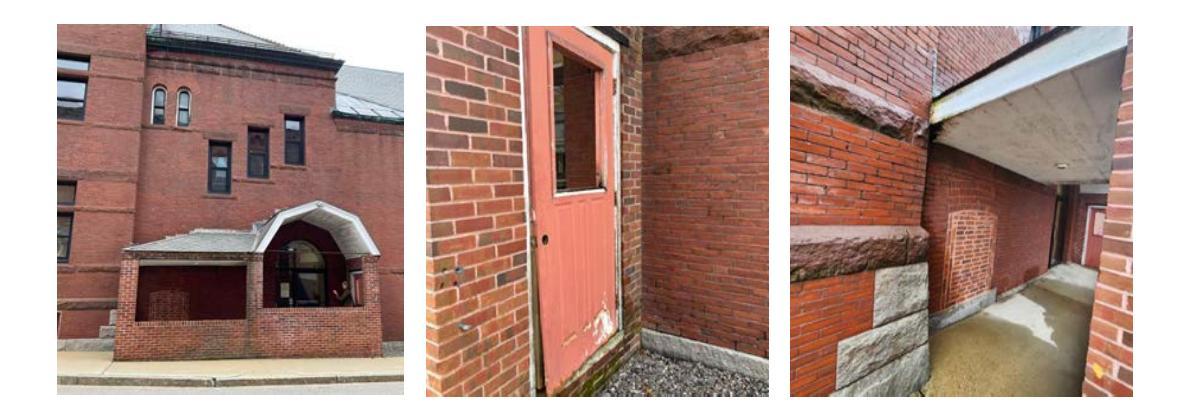
7. The existing side porch addition for ADA access is in severe disrepair. There is moisture damage to the roof, brick doors, and trim. The roof assembly will need to be replaced or demolished

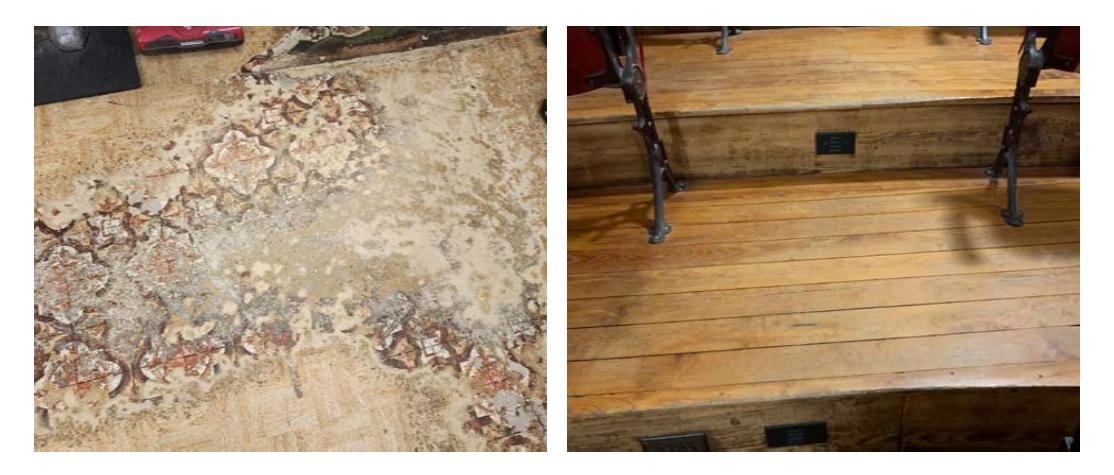
Fix creaky flooring that is typical throughout the building with focus in the opera house, secure any loose boards, & verify localized needs for reinforced substrates. Wood flooring finishes are worn and in need of repair and repaint. Acoustic insulation to floor ceiling assembly between theatre & city offices is needed for noise isolation between city hall and theatre use.

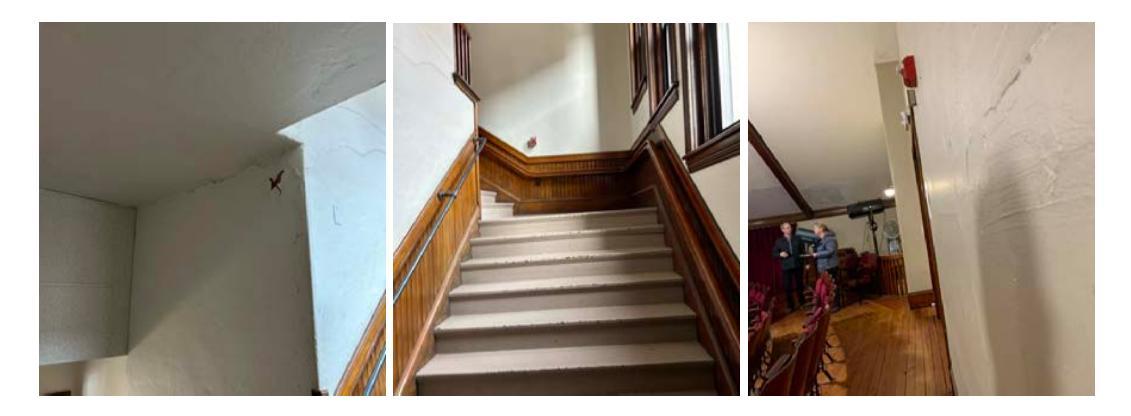
2. Drywall is worn and damaged in most areas of the interior. Plaster on lathe is in need of repair in various parts of the building. The decorative wood trim should be repaired or replaced where needed.

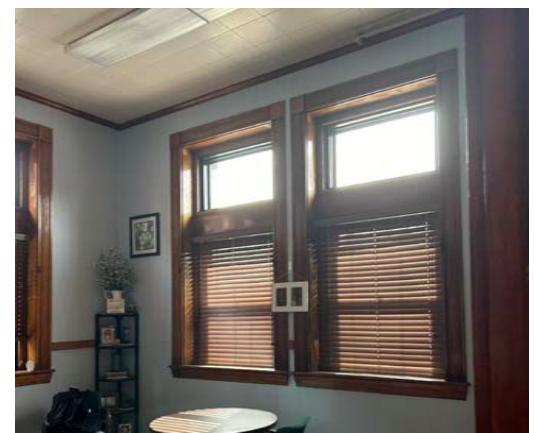
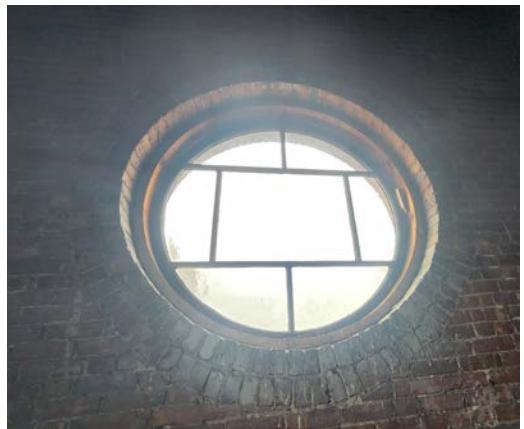
3. The finish of interior jambs, sills, & window flashing or sealant is in need of repair throughout the building.

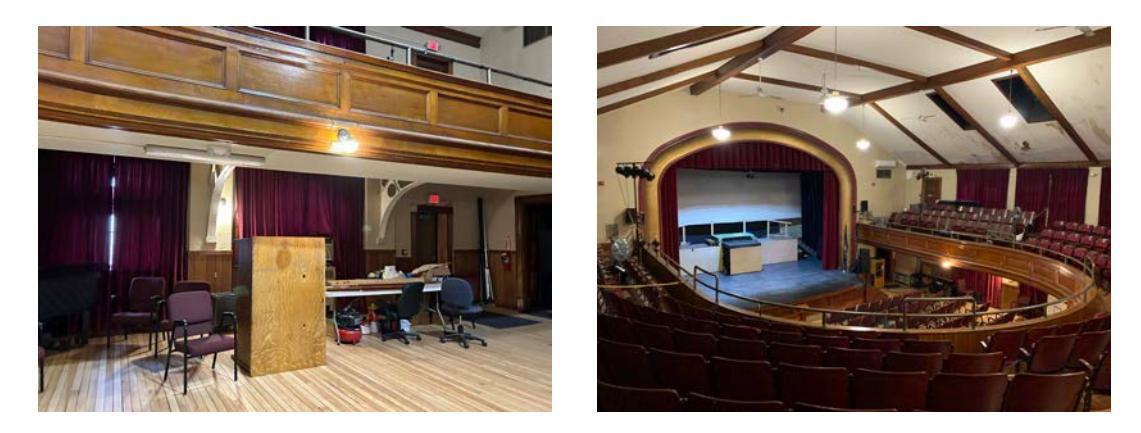
4. All railings should be made code compliant especially those in the mezzanine of the opera house.

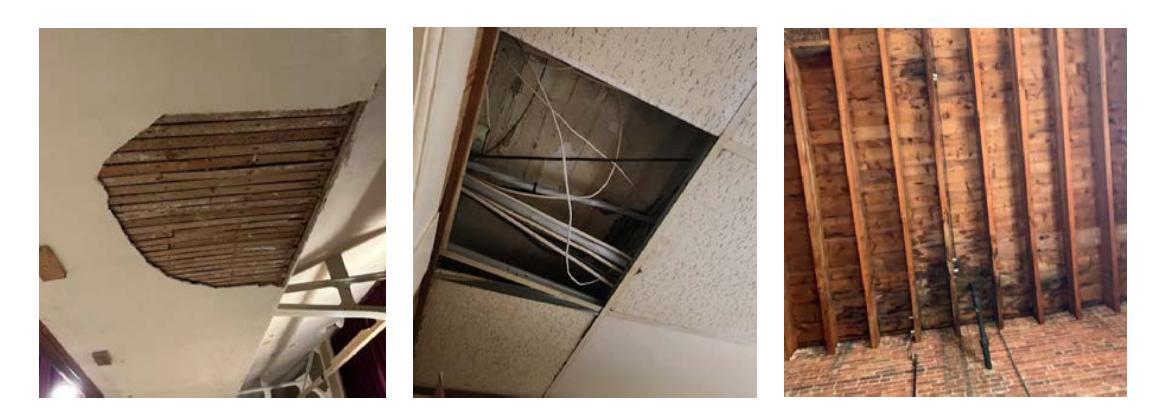
5. Repair, patch, & repaint holes in walls and ceilings throughout the building. There is evidence of moisture damage in various parts of the ceiling that are in need of repair.

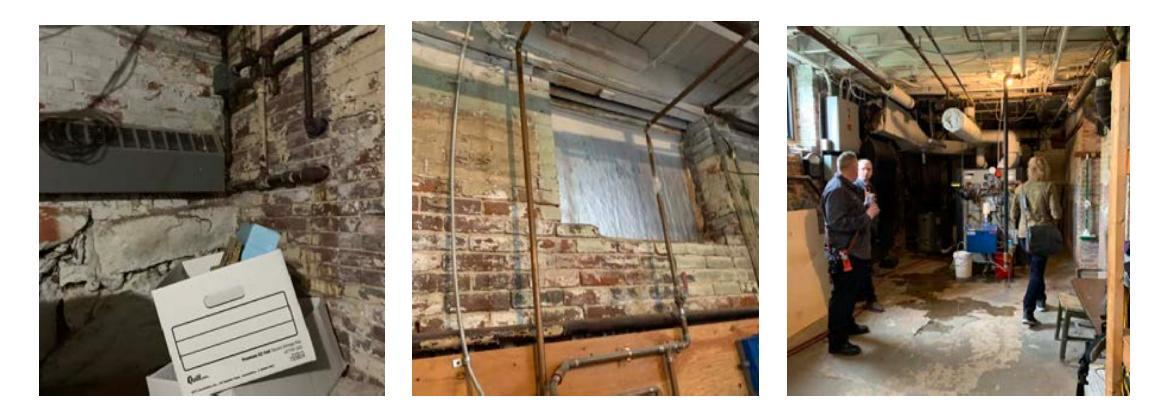
6. Basement is damp and musty. There is cracking and spalling at masonry mortar joints due to moisture and vapor infiltration. The bricks along the exterior wall in the mechanical room have deteriorated severely. Various holes in masonry walls at utility penetrations are allowing additional moisture and thermal infiltration. The built up wood flooring should be removed and replaced with concrete slab on grade assembly. The column bases throughout the basement should be investigated at the foundation for moisture damage.
