Conditions Assessment & Feasibility Study

Franklin City Hall & Opera House Franklin, NH

March 22,2024

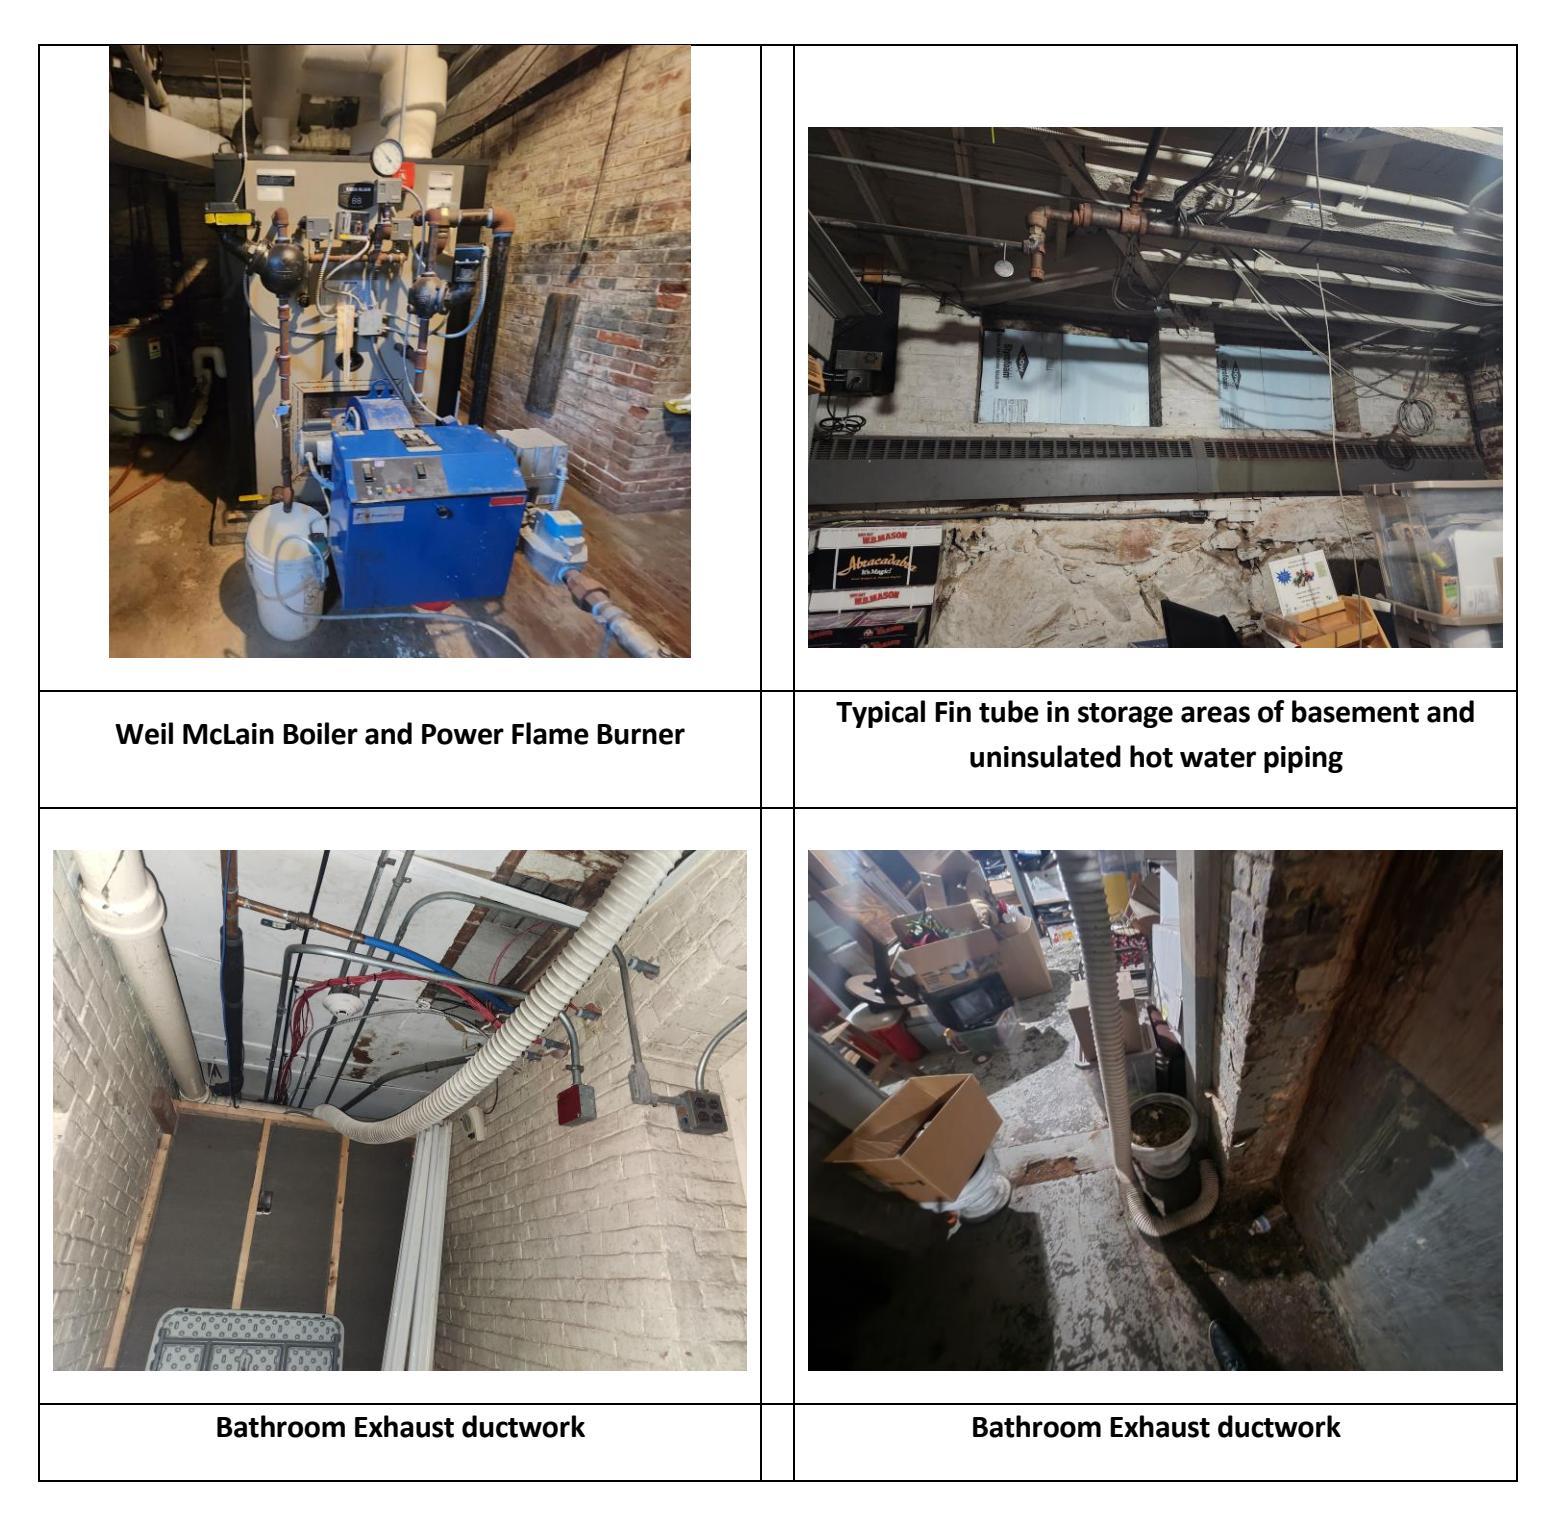
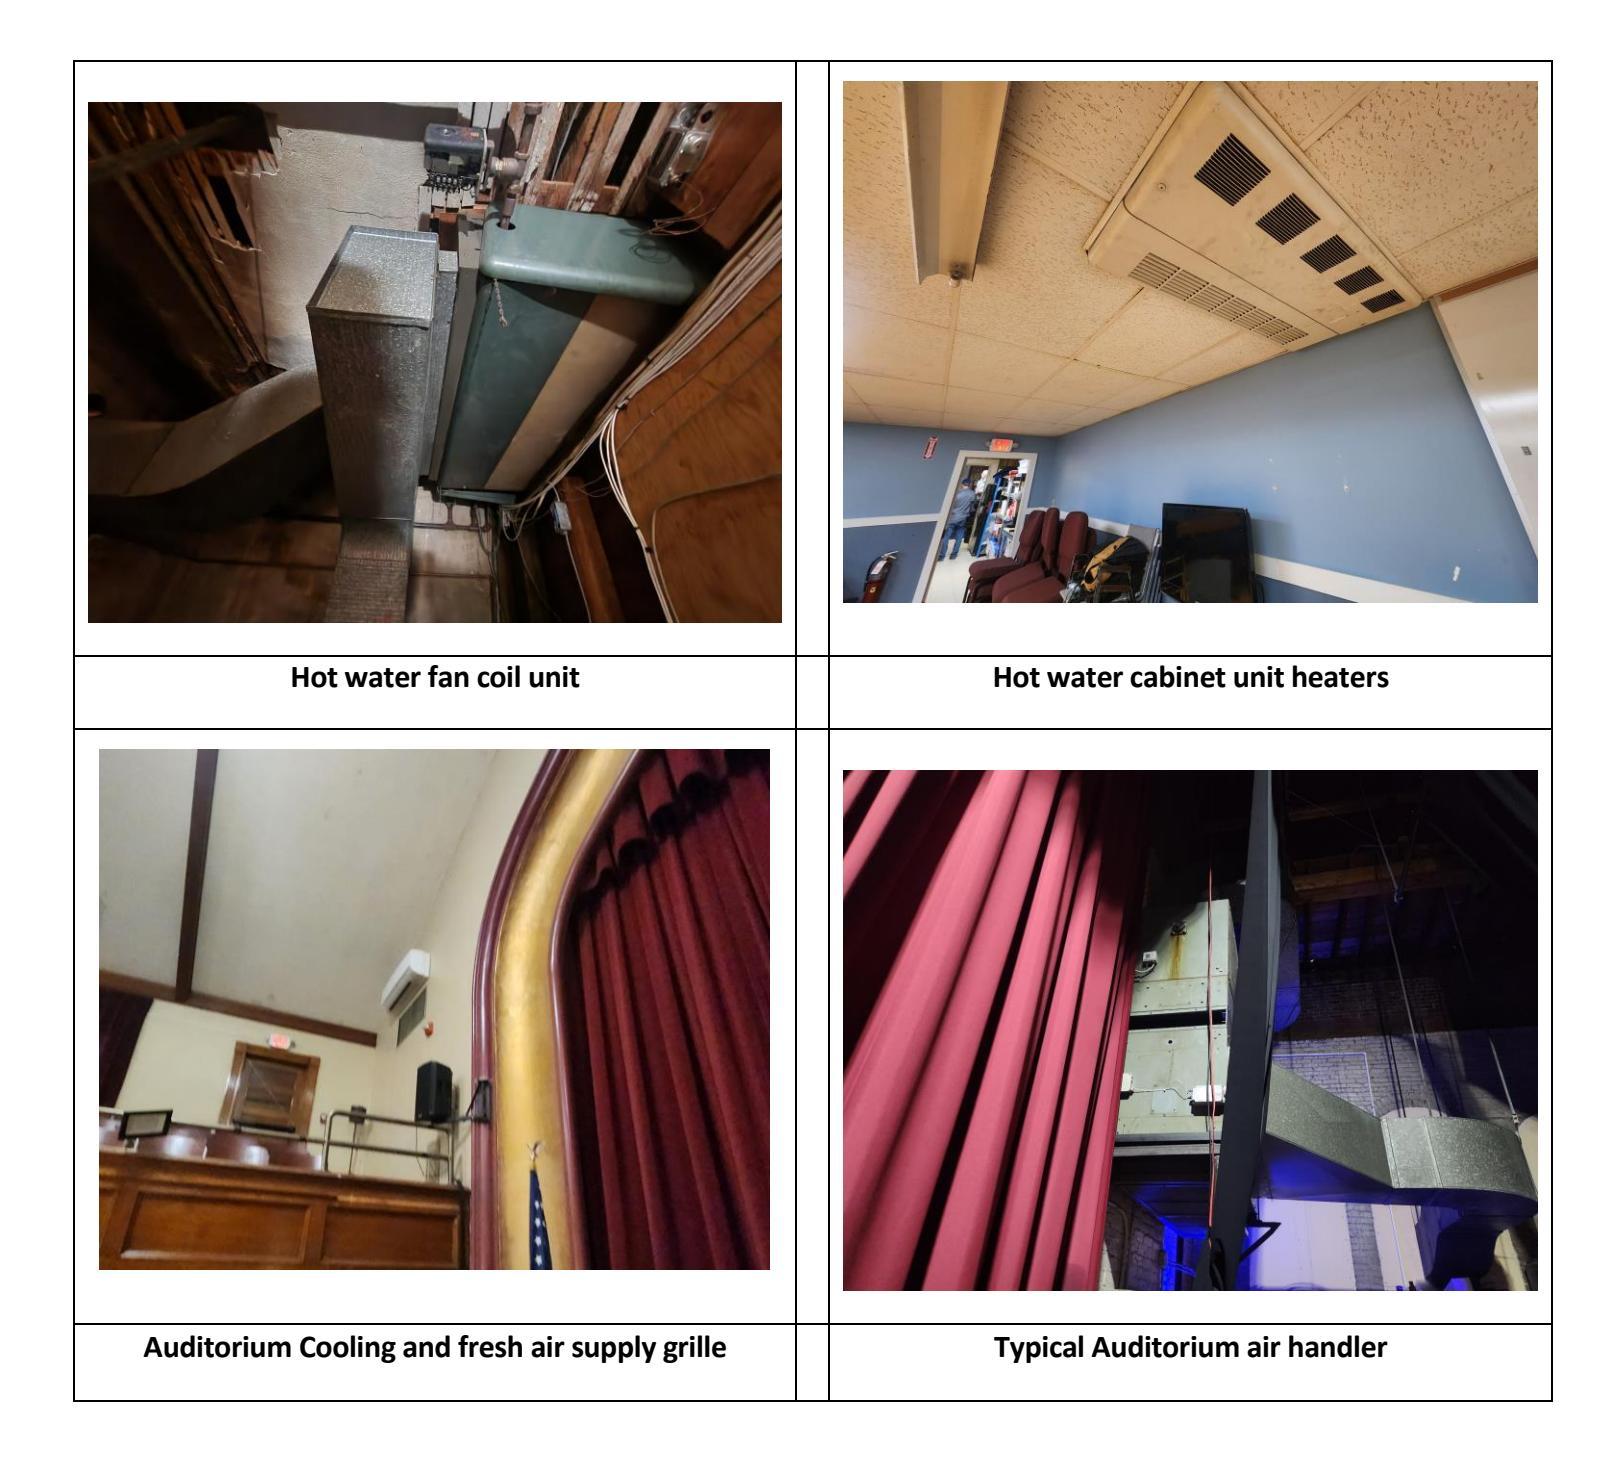
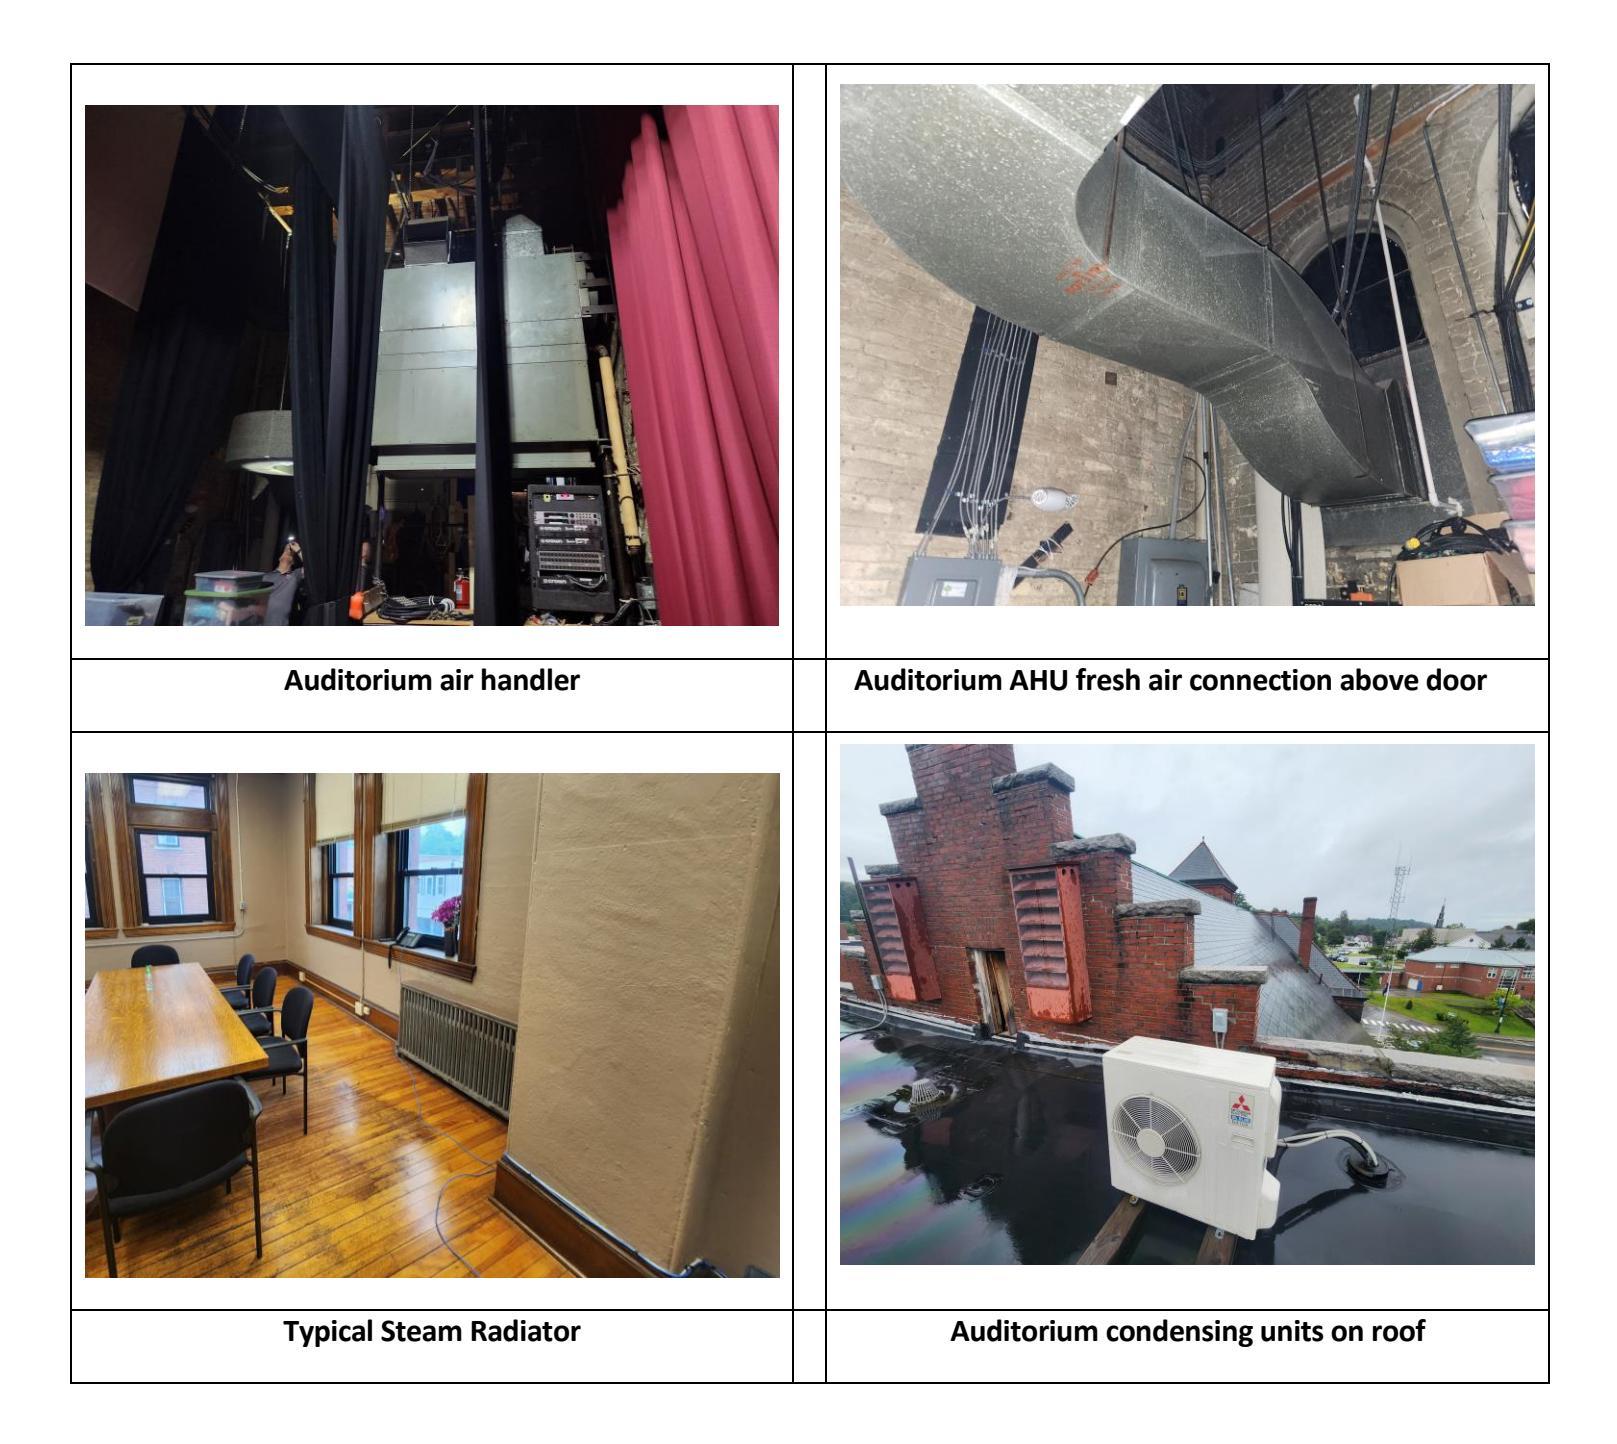
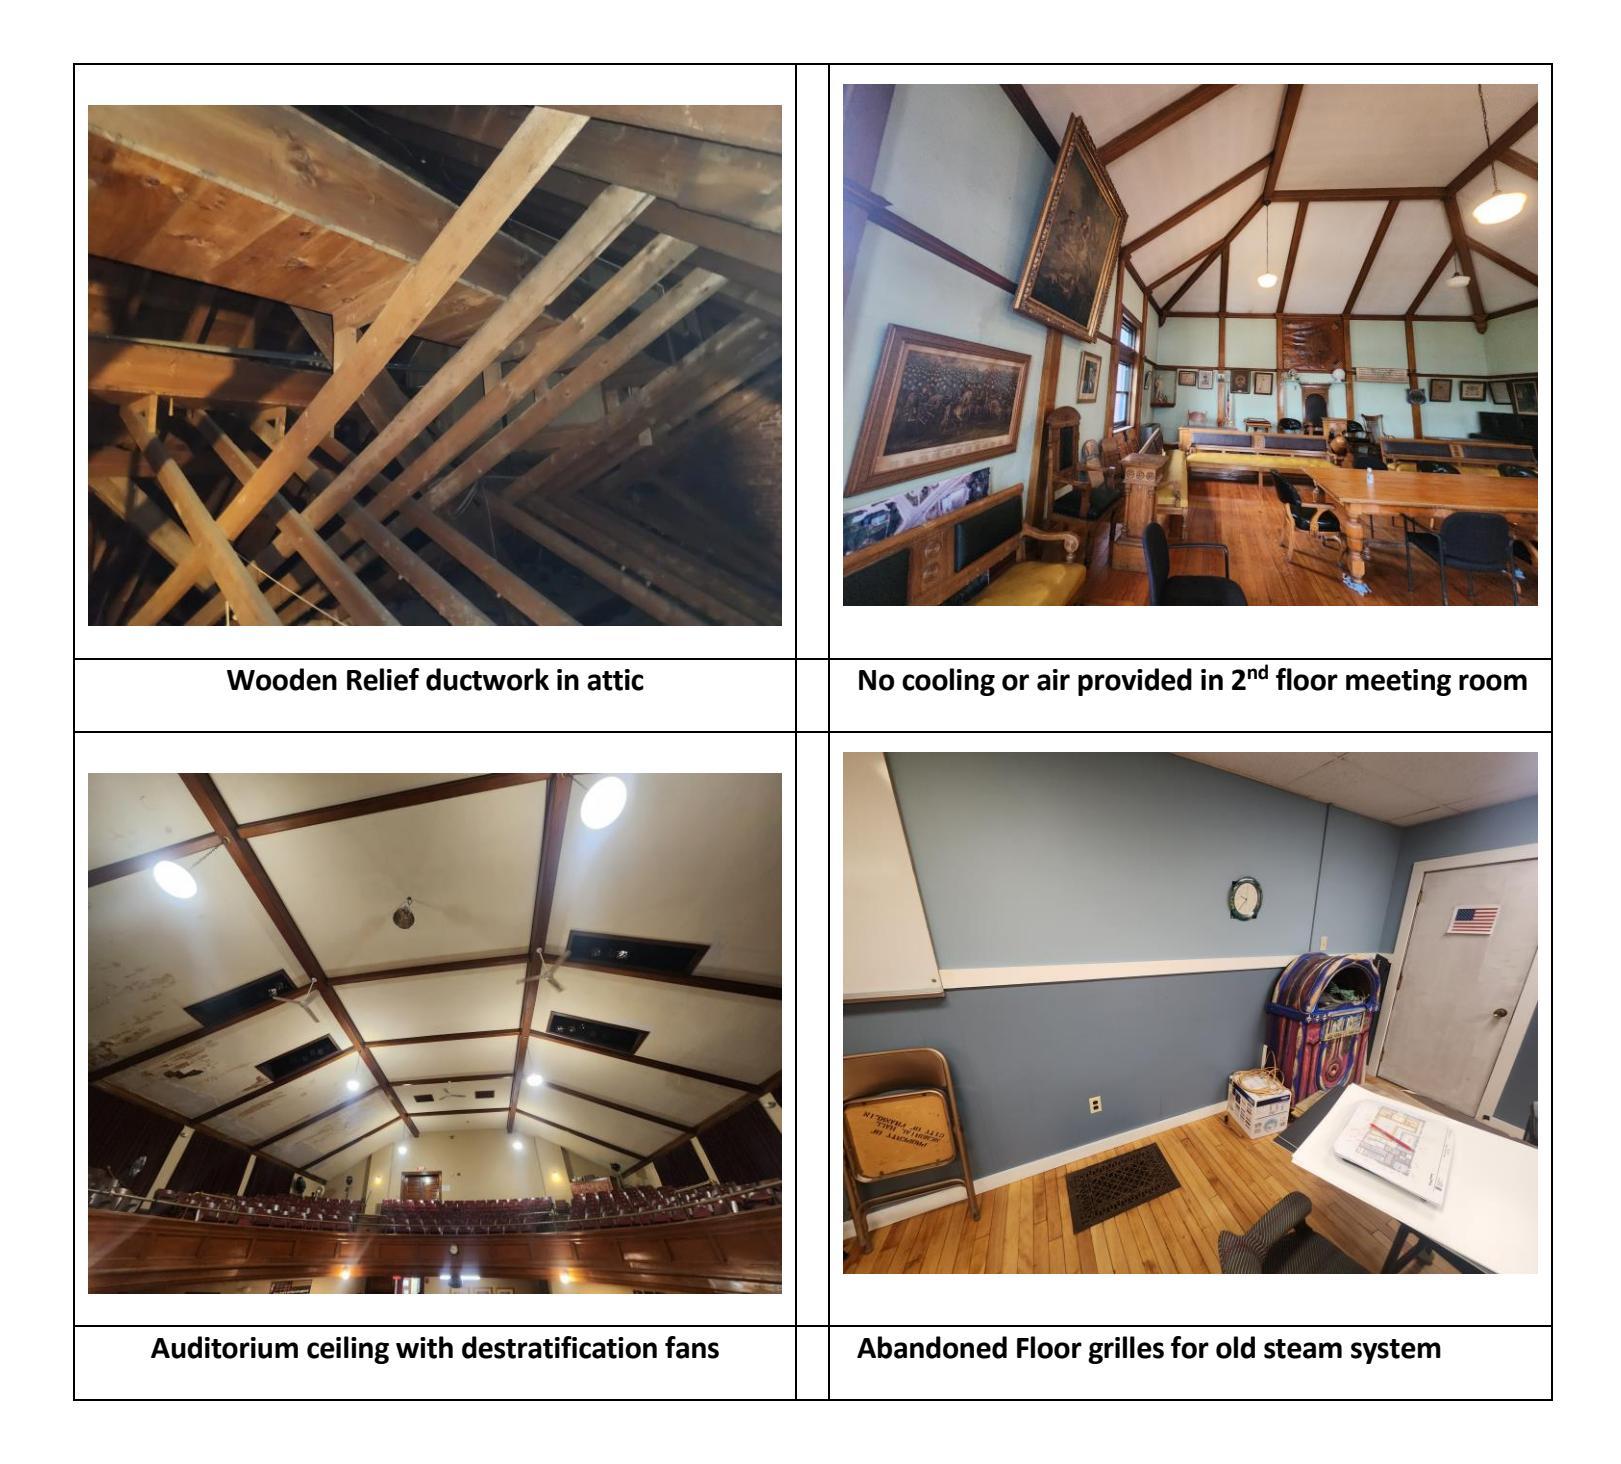
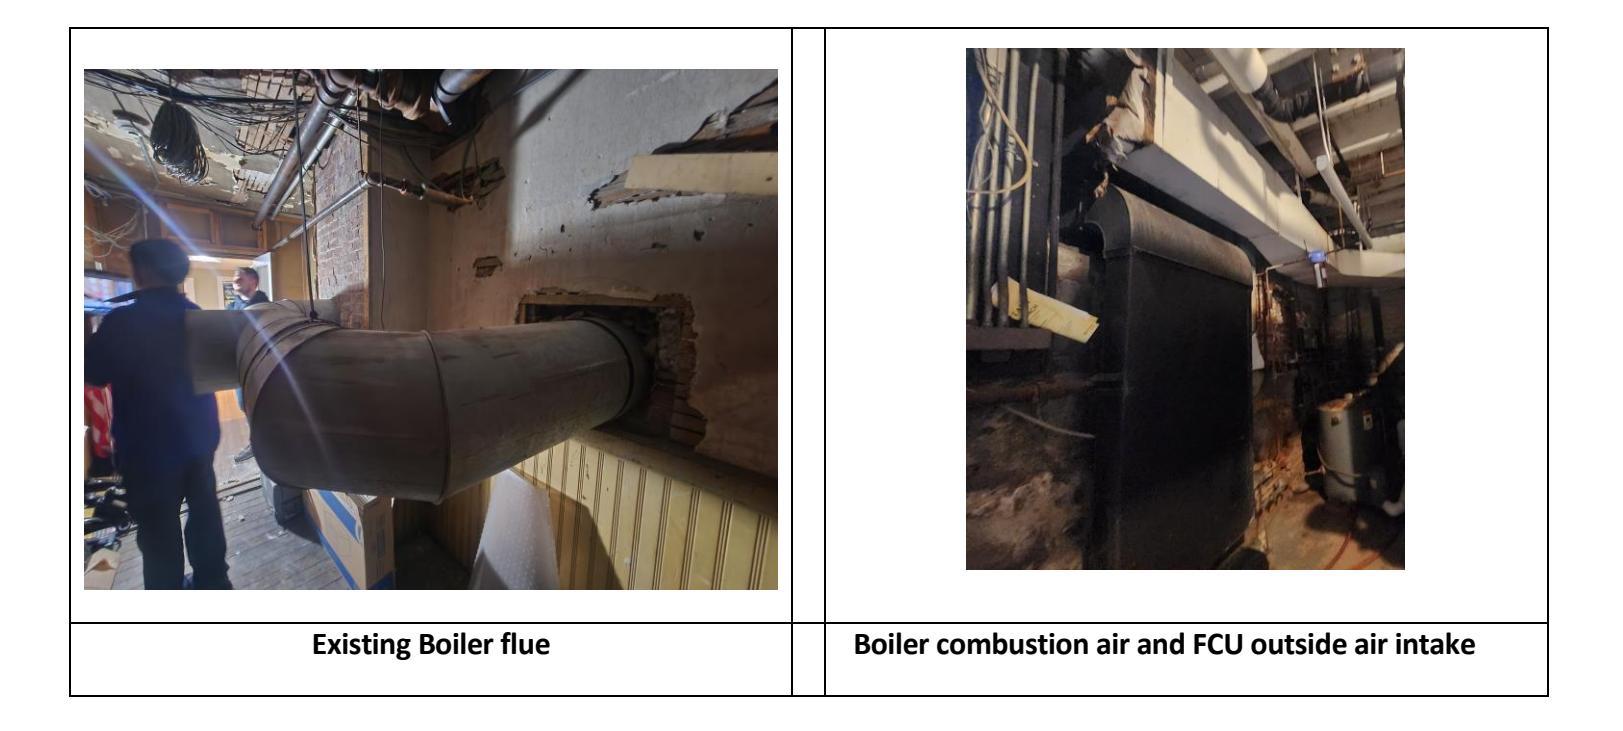
HVAC Digital Photographs

The condition of the existing HVAC systems throughout the building was observed to be in fair to poor condition. The existing systems seem to have been pieced together as walls, programs and layouts have changed over the years. It also appears that the heating media has been changed at some point in time from Steam to hot water. Many items are dated and inefficient for the task being performed.

The main heating plant of the building appears to be relatively new compared to the rest of the building and infrastructure. The heart of the heating plant is a Weil McLain Series 788 boiler with a Power Flame Natural Gas burner. The boiler and burner combination have a maximum heating supply capacity of approximately 1,650,000 BTU. Based on the serial numbers affixed to the burner and the boiler it appears that they were manufactured in 2015 and installed shortly thereafter. Giving them an age of 8 years old. The American Society of Heating, Refrigeration and Air-Conditioning Engineers (ASHRAE) publishes a paper listing the typical life expectancy of HVAC equipment periodically. This list is prepared to give building owners and developers ideas of when to plan for renovations and replacements based on equipment type and size. ASHRAE lists the cast iron boiler as having a useful life expectancy of 35 years while the burner has a useful life expectancy of 21 years meaning that both the boiler and the burner are well within a typical units useful life expectancy. The Boiler and burner appears to still be producing steam as opposed to hot water. Some older steam system accessories were observed to be abandoned in place in the basement and not connected. The condition of the boiler and the burner were observed to have a general rating of [3].

The bathrooms were exhausted with ceiling exhaust fans. The fans were connected to a series of ductwork that communicated with the outside. The Basement men's bathroom was observed to not be ducted outside as was the women's room on the first floor. The basement bathroom ductwork was terminated in the storage area near the ground as can be seen in the pictures. The bathroom ventilation was observed to be in [0] to [1] condition. The fans are expected to have a useful life of 20 years. It is assumed that the fans are at or past this age based on their physical condition and that rest of the building.

The hot water heating elements throughout the building are dated and appear to be designed for the steam that was originally produced by the boiler plant. No exact age or models could be determined at the time of the site visit due to paint, locations and obstructions. They are estimated to be 25-30 years old though based on condition and physical appearance. The existing fin tube, cabinet unit heaters, ducted fan coils, and steam radiators all appeared to be a [1] to [2] rating. They are aged not optimally placed for the spaces that they serve, and the system has been pieced together multiple times to accommodate new layouts and programs. Steam radiators and the like are expected to have a useful life of 20 to 25 years. It is expected that most elements in the building are at or past this age.

The make and model of the heat and ventilation units that serve the auditorium were unable to be observed based on accessibility an storage in the way. The units appeared to be old if not original to the building based on the controls and condition of the overall unit. They appear to bring in outside air from ductwork that is routed to the exterior wall. The outside air is mixed with return air and then it is heated up via a steam coil in the unit. The air is then delivered to the auditorium through a grill in the side wall above the stage. The units do not appear to have any cooling in them. The overall condition was observed to be [2]. It was noted by the Franklin town reps that the units were in the way of production and were a nuisance in their current state. Typical steam air handlers per ASHRAE have a useful life expectancy of 20 years. It is assumed that they are near or past this age.

The auditorium has roughly 6-tons of cooling provided via two mini splits. The Mini splits appear to be fairly new and based on their equipment tags were manufactured in 2015 the same time as the boilers were replaced. This puts them at 8 years old when ASHRAE suggests a useful life expectancy of 15 years. The mini splits appeared to have a condition rating of [4] at the time of the site visit.

The ductwork in the attic that is meant to relieve hot air and excess pressure when the auditorium air handlers are providing ventilation, are made of what appears to be uninsulated and unlined wood. The overall condition based on its original intent is [3]. However, this should be changed to a more permanent material that would be less likely to sweat and cause water damage when air conditioning is added in any future fit outs.

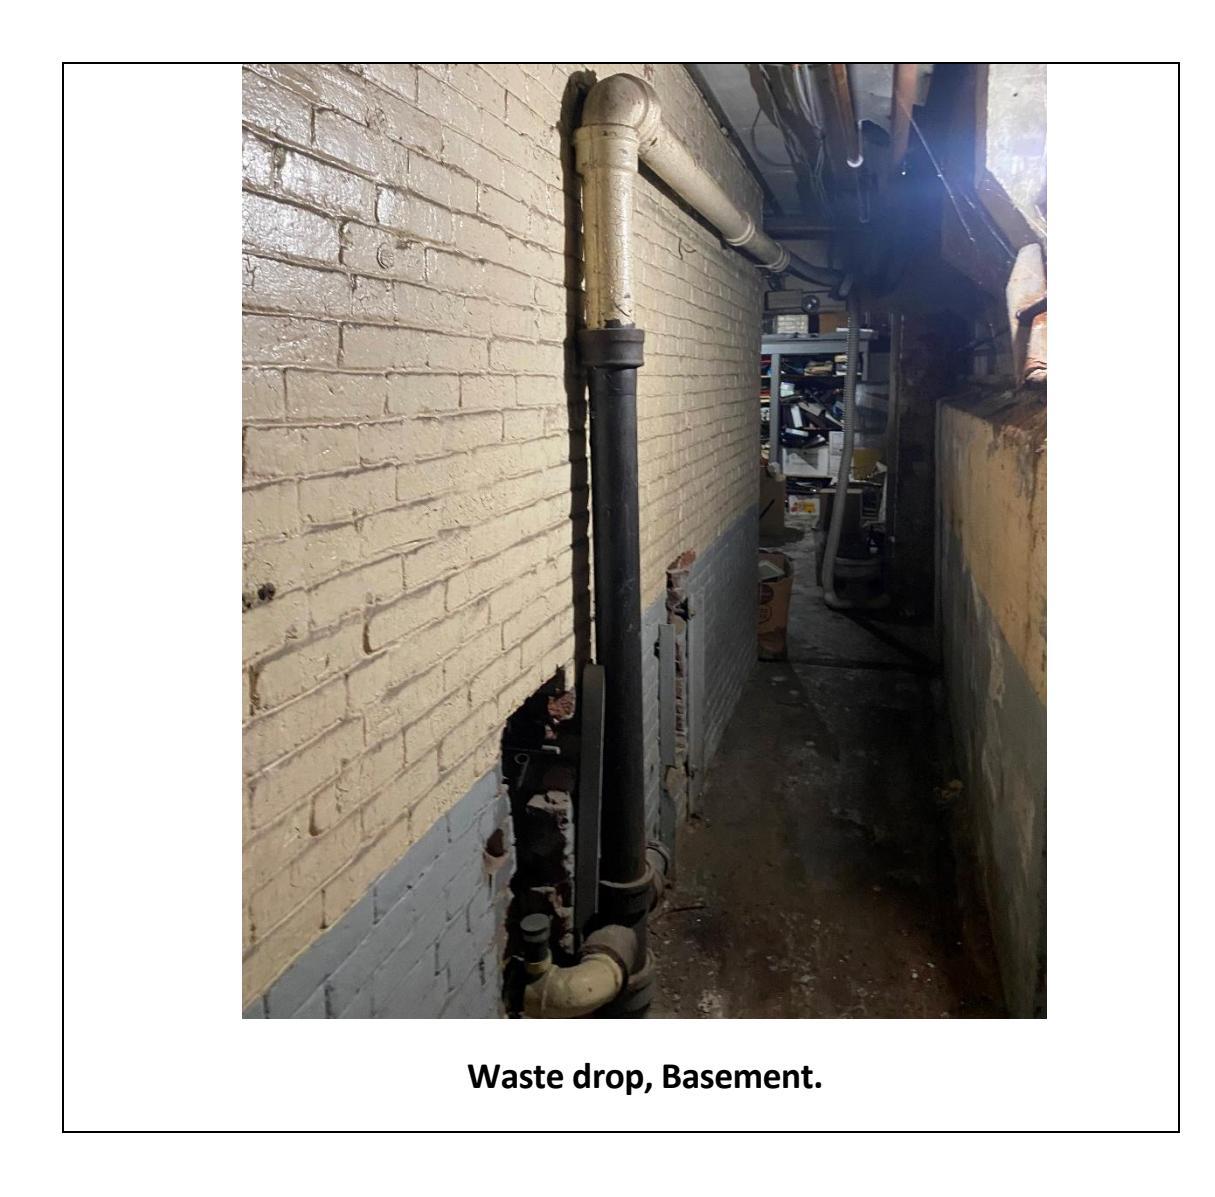
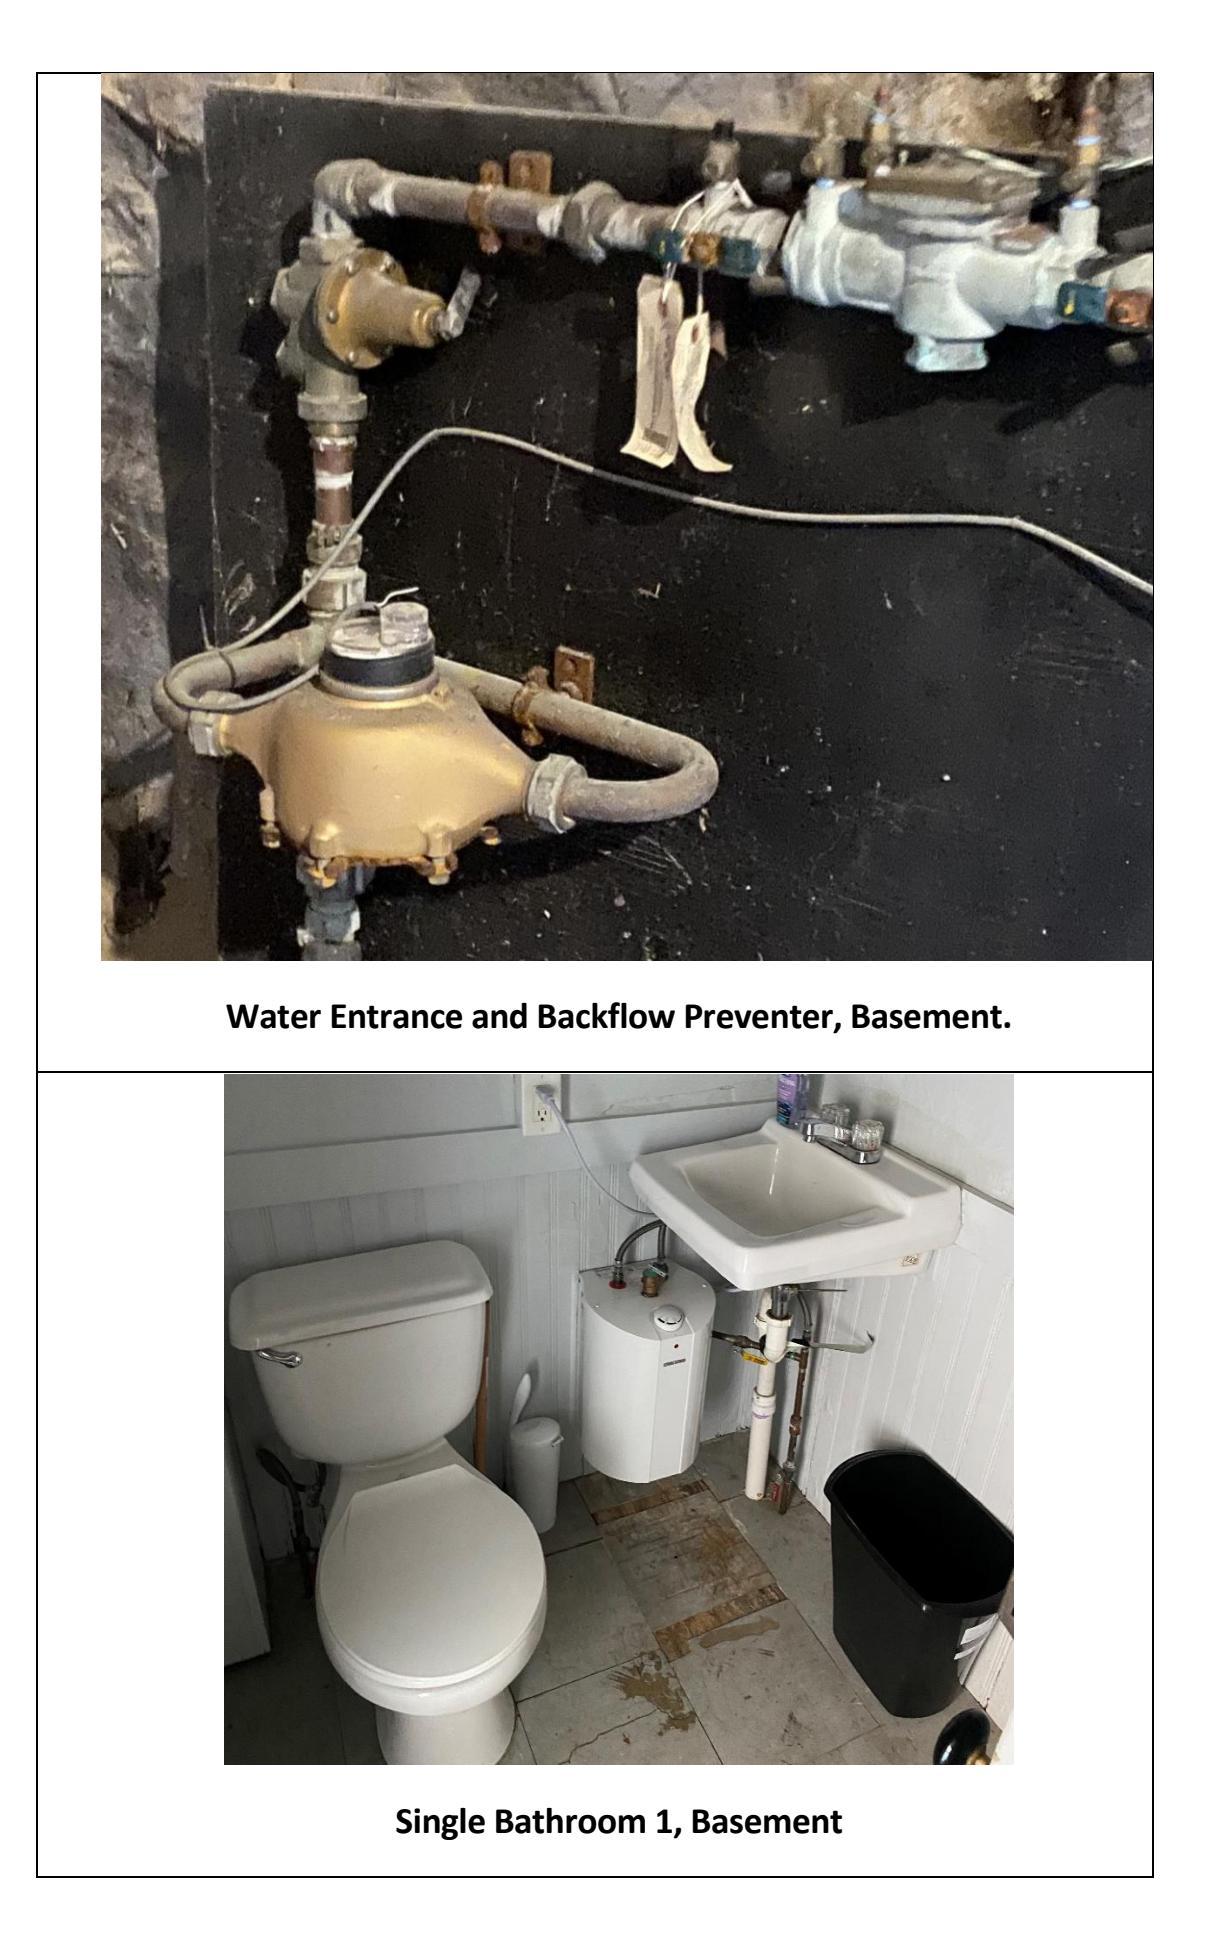
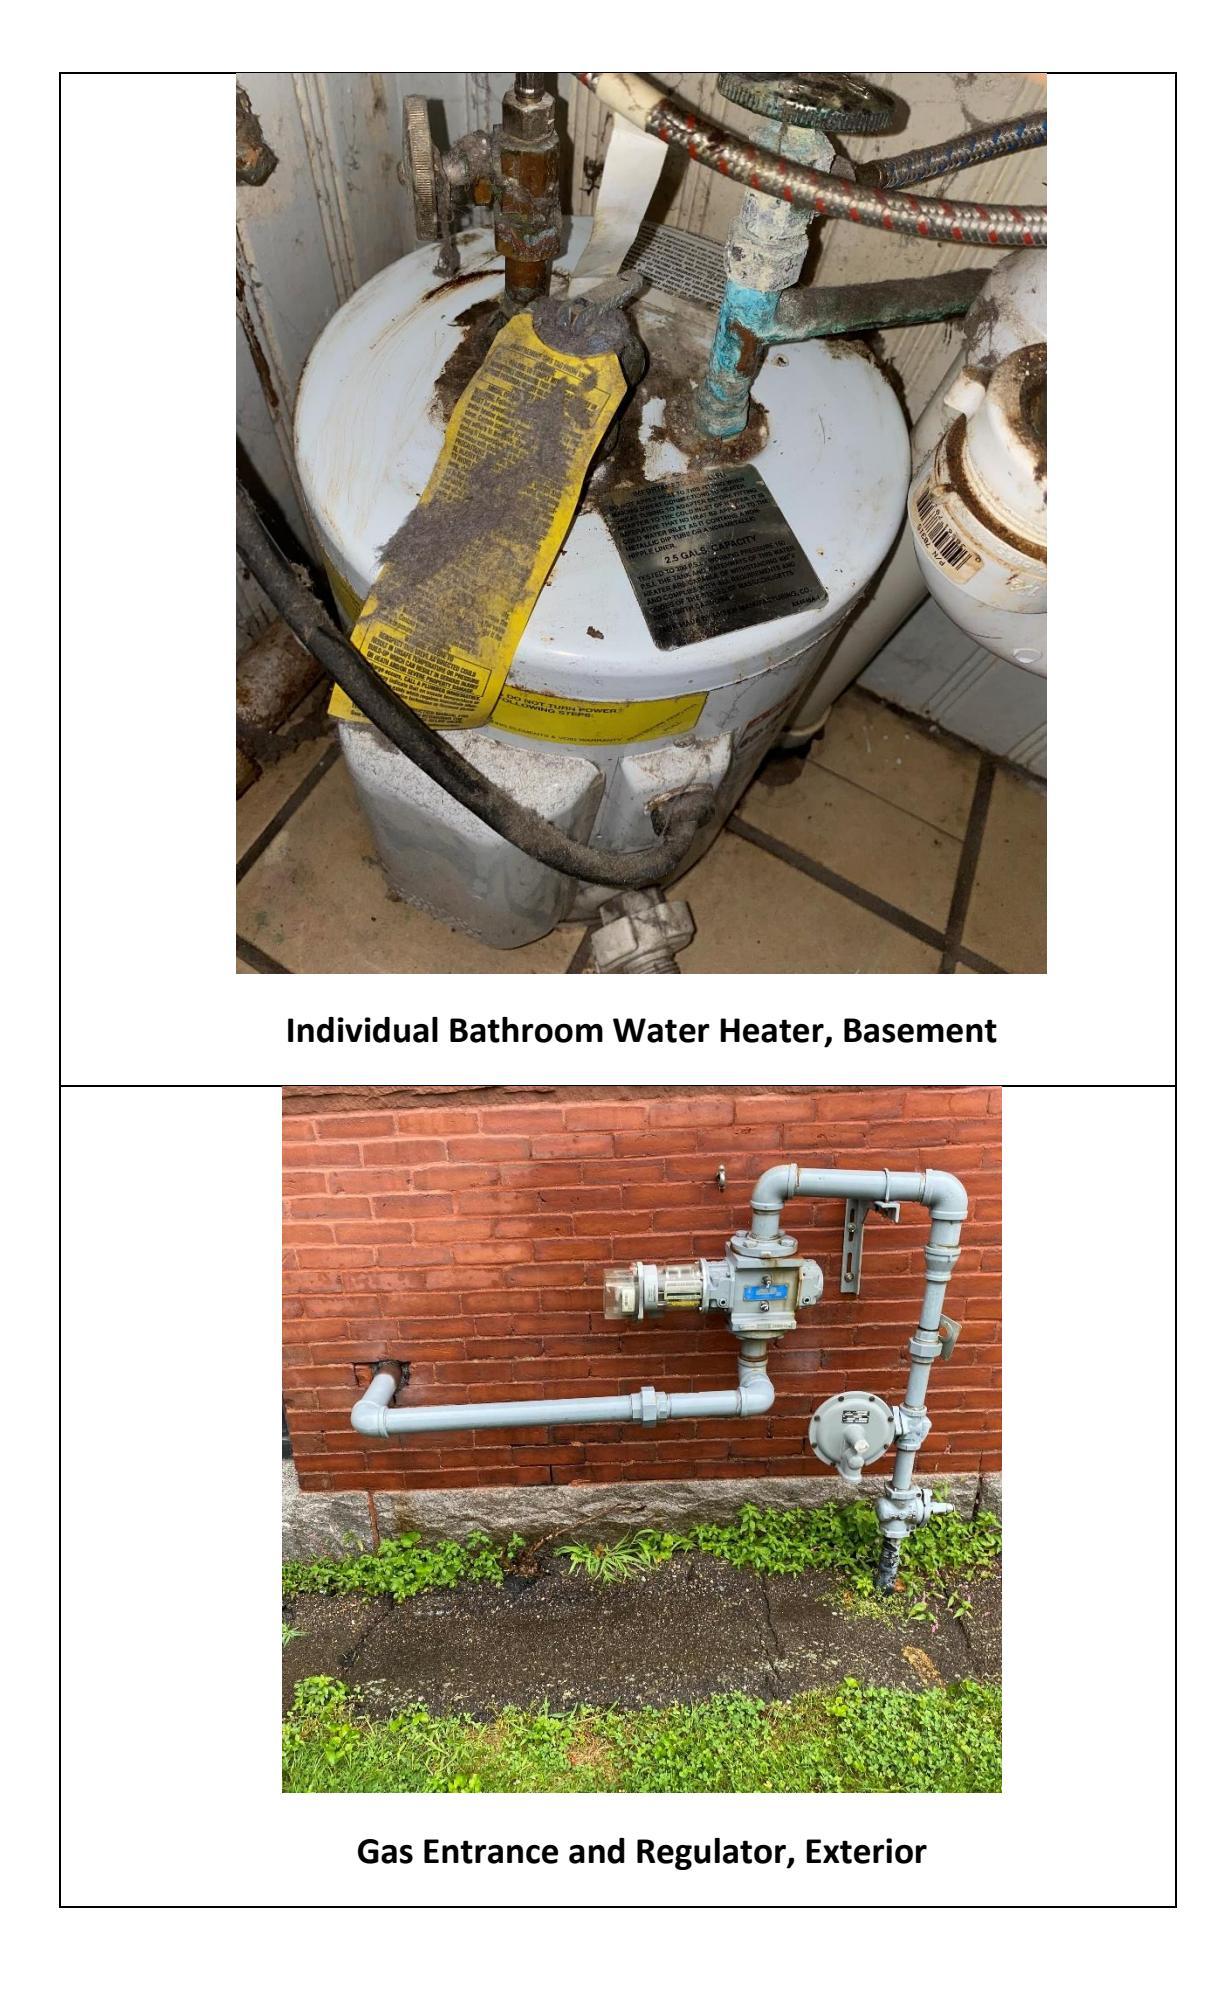
Plumbing Digital Photographs:

The building has its own 4" sanitary run out to the street, it is assumed that the sewer connection is in the street on the East side of the building since there is a visible sanitary line with a cleanout below a grate in the floor that runs sloped downwards towards east side of the building. The existing system will be adequate for the future renovations and additions desired. Rating: 2.

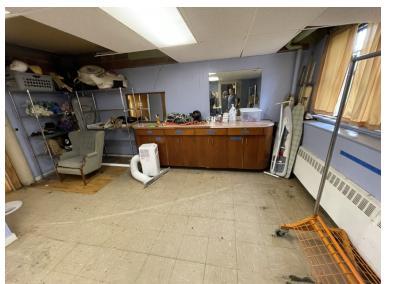
Figure 22.3

22.3	Women's dressing room is fairly large but is in need of updating and renovation.
22.4	Men's Dressing room is quite small and in need of updating and renovation.
22.5	There was not an apparent production break room at the time of assessment.
22.6	Rehearsal room was not diminutive but is also not an adequate size to tape out the entire stage. Area is not column free.
